INQUIRY INTO THE COLLAPSE OF TEXAS TOWER NO. 4

HEARINGS BEFORE THE PREPAREDNESS INVESTIGATING SUBCOMMITTEE OF THE COMMITTEE ON ARMED SERVICES UNITED STATES SENATE EIGHTY-SEVENTH CONGRESS FIRST SESSION

MAY 3, 4, 10, 11, AND 17

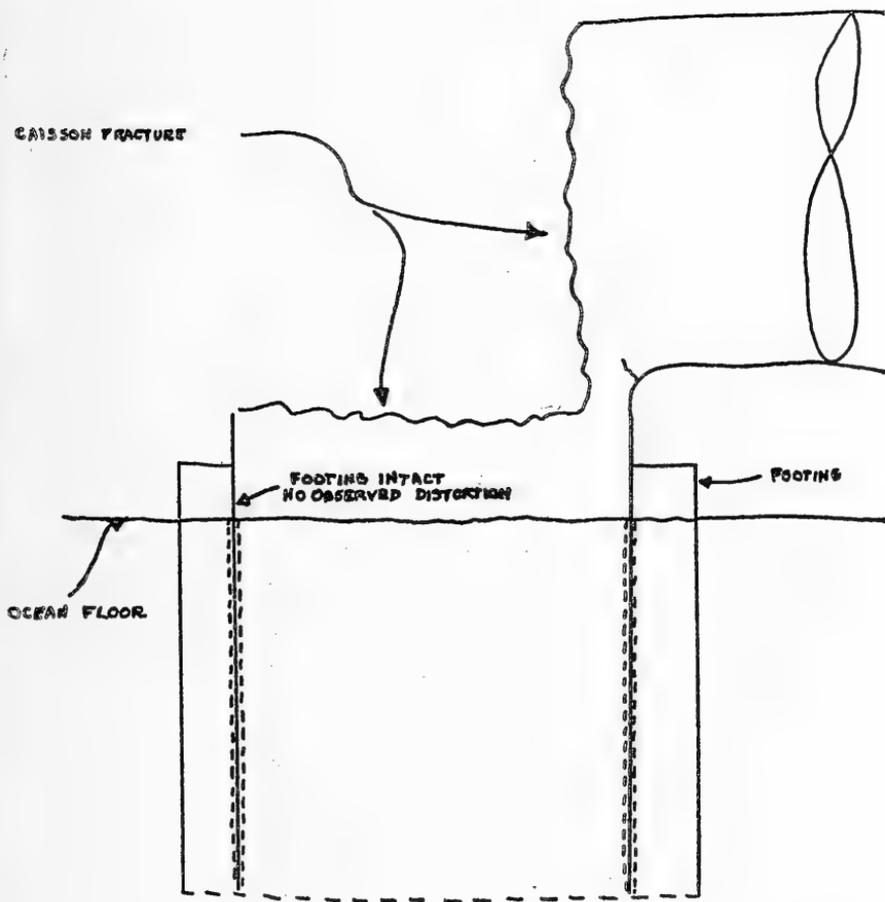
TEXAS TOWER NO 4
TYPE FRACTURE
CAISSON "A" + "C"

CAISSON FOOTINGS
"A" + "C"
PHOTOS SHOW PARTS OF FRACTURE

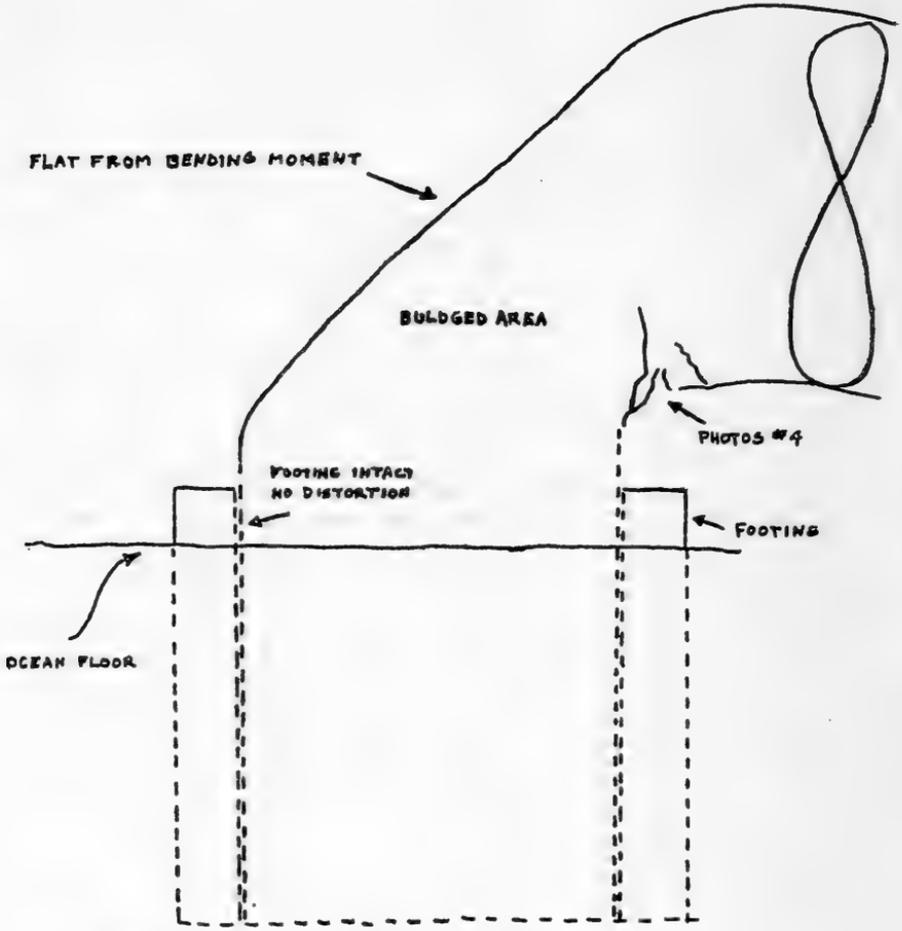
SEVERAL PHOTOS #4
OF FRACTURED END

TEXAS TOWER NO 4
BENT CAISSON "B"
